PORT OF SILVERDALE
2019 COMPREHENSIVE PLAN

APPENDIX F: OLD TOWN PUB STRUCTURAL ANALYSIS

September 10, 2018
File No. 262018.077

Subject: Port of Silverdale Old Town Pub
Structural Evaluation

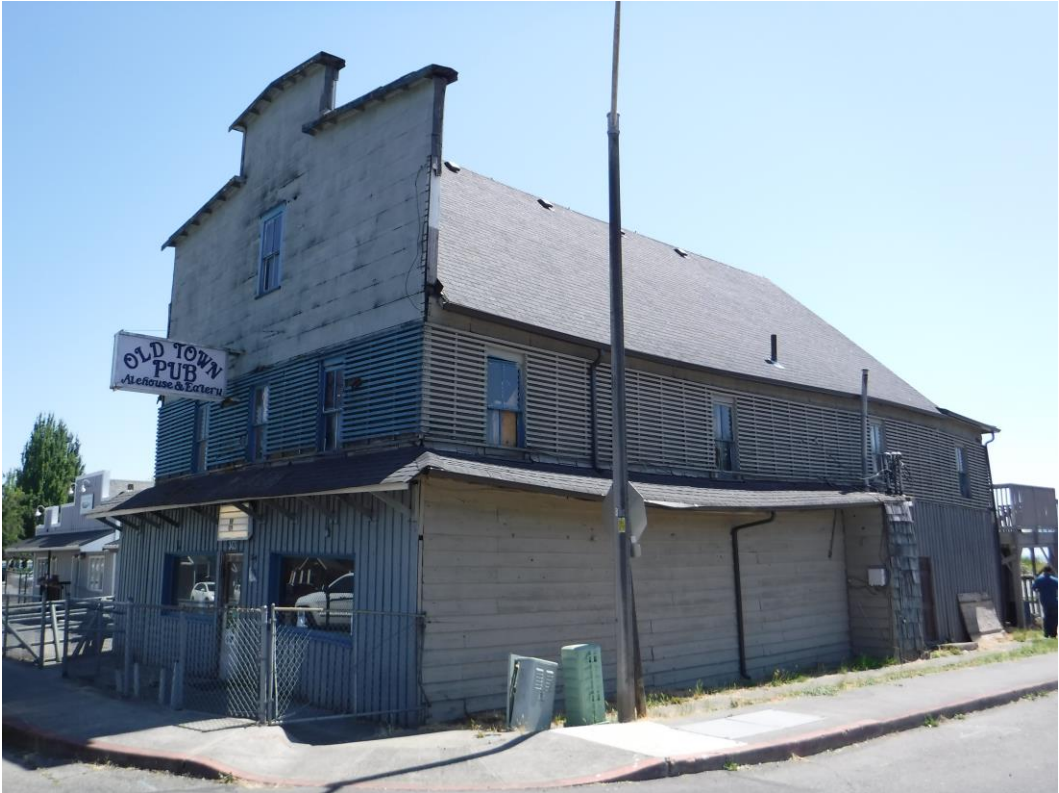
Photograph 1: Northern exterior of building.

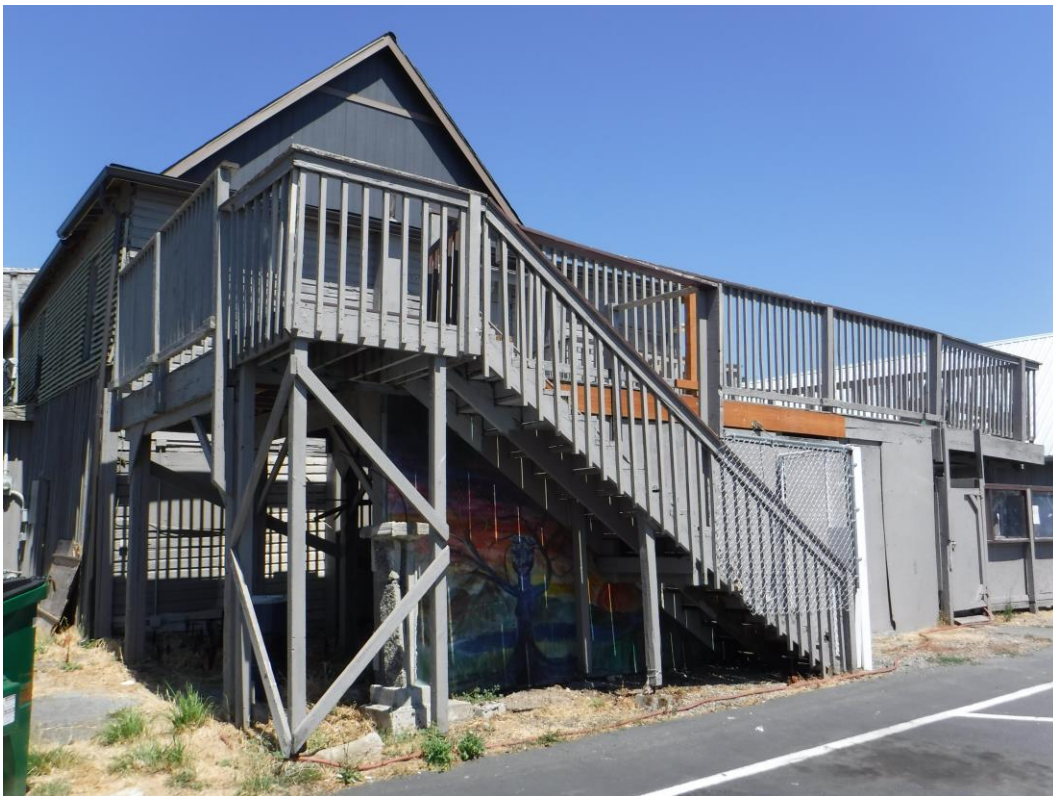
Photograph 3: Southwestern exterior corner of building.

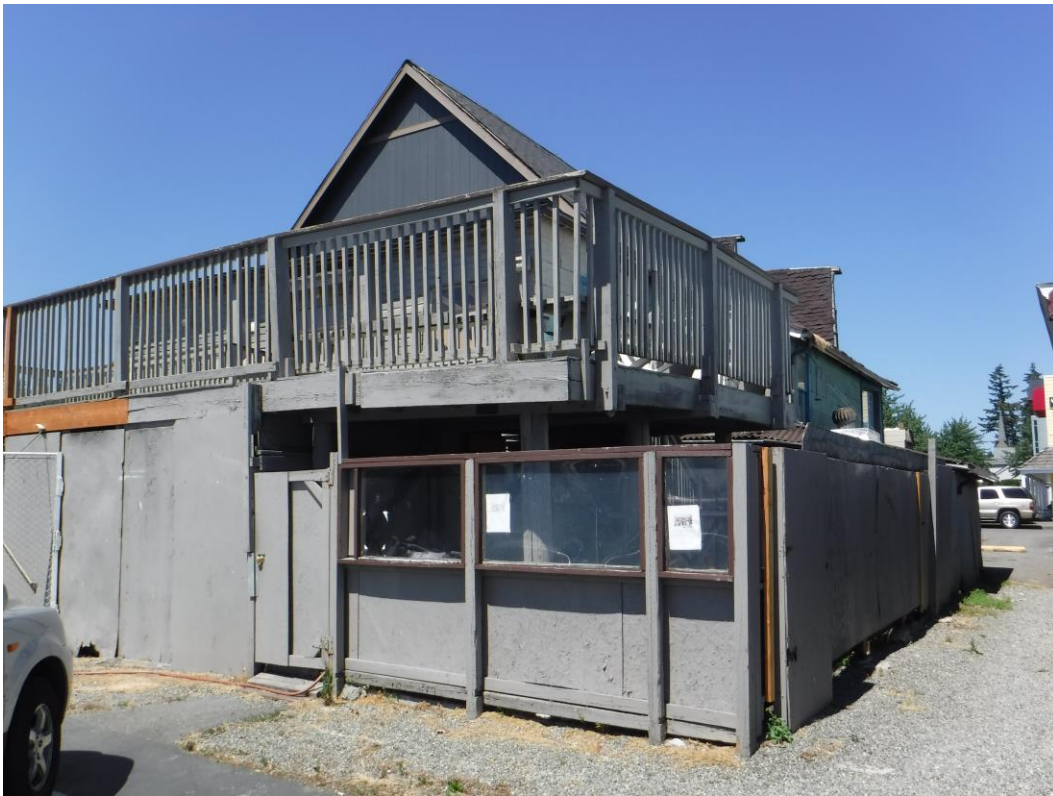
Photograph 4: Deck at southern exterior of building.

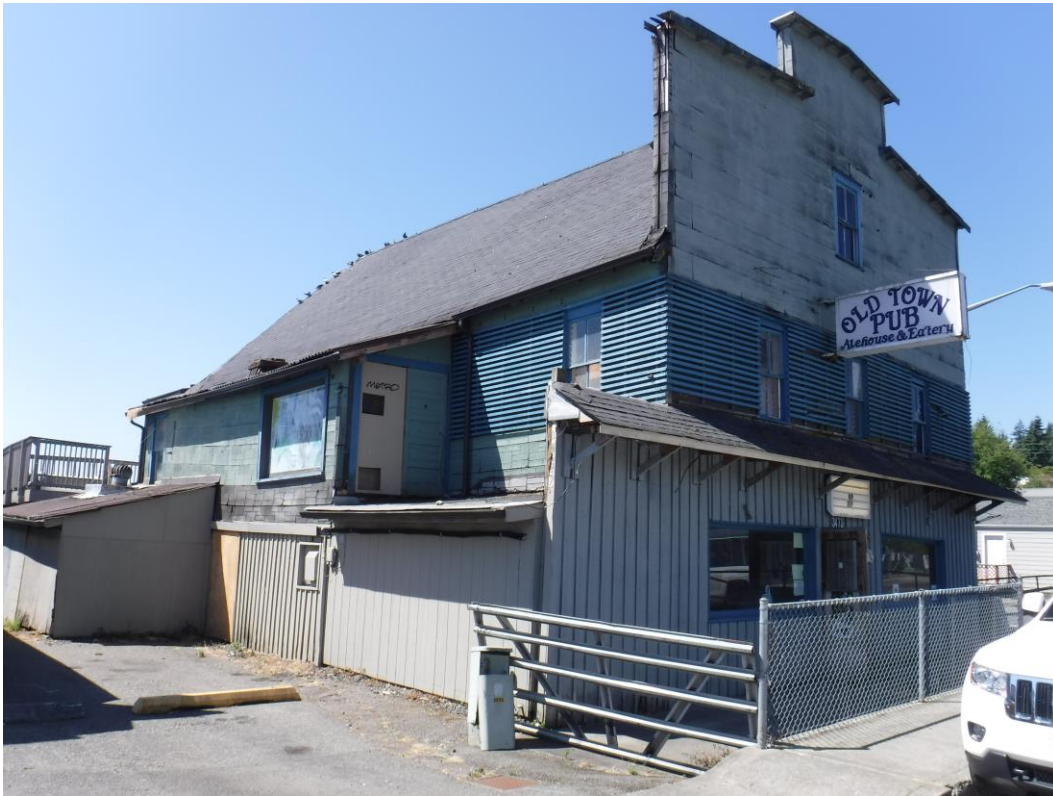
Photograph 5: Deck at southeastern exterior corner of building.

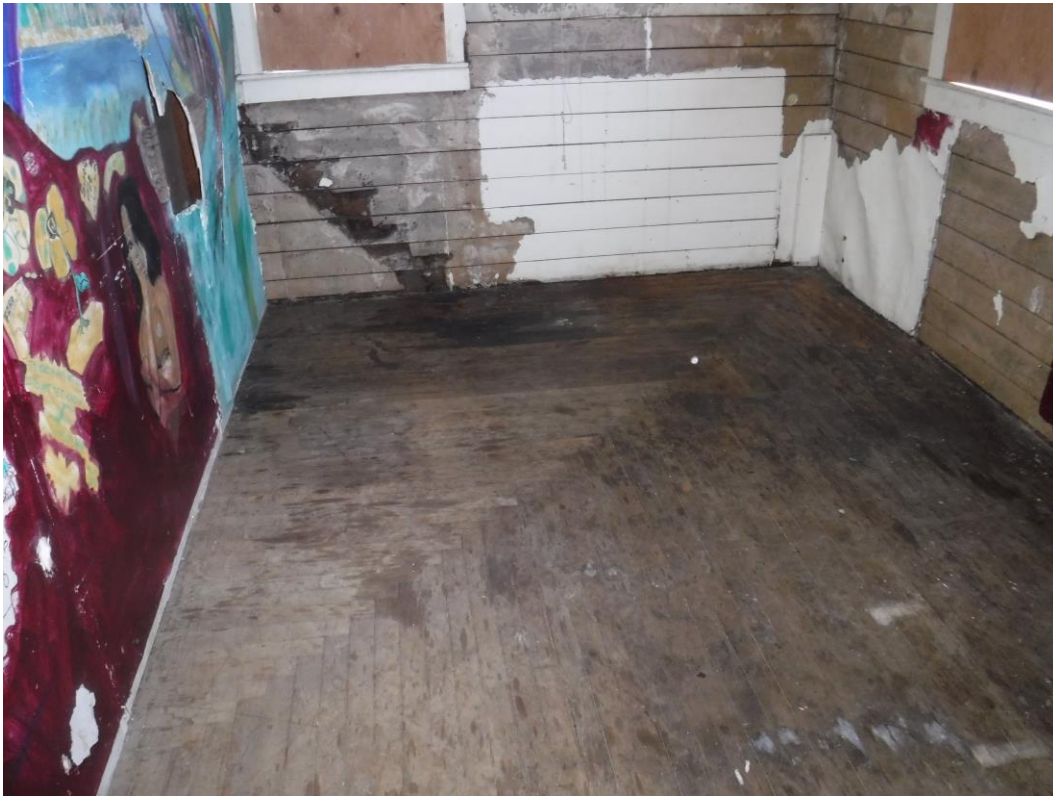
Extensive settling of the building was observed through visual observation and the measurement of sloping floors. Most settling appears to be occurring at the exterior sides. At both the first and second floors, the floor sloped away from the center of the building to all four exterior walls. The maximum slope measurement taken on site was approximately 1/2-inch per foot. This occurred at both the first and second floor in the northwest portion of the building. The settling appears to be due to an inadequate foundation system. The building does not appear to have an adequate concrete foundation system, and it is anticipated that the building does not sit on piling, as is typical near most waterfront areas in the Pacific Northwest.

Photograph 11: Underside of second floor with slope toward exterior of 12-inch per 1-foot.

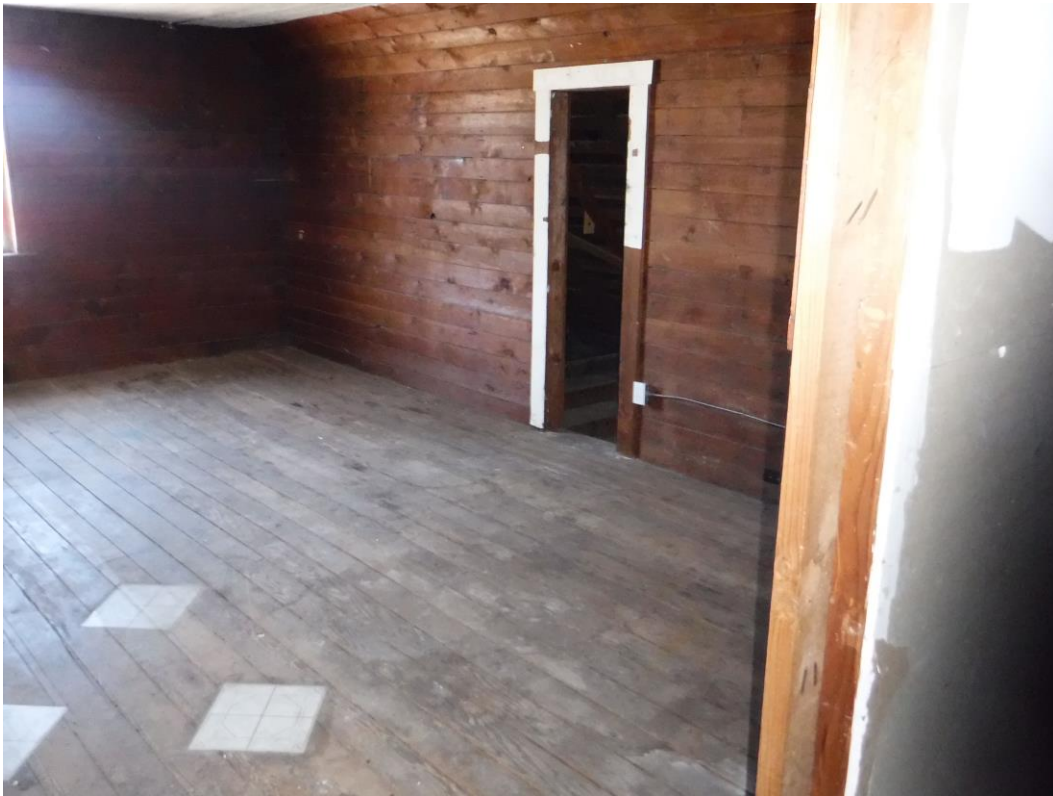
Photograph 12: Second floor at building center with high point (slope east and west).

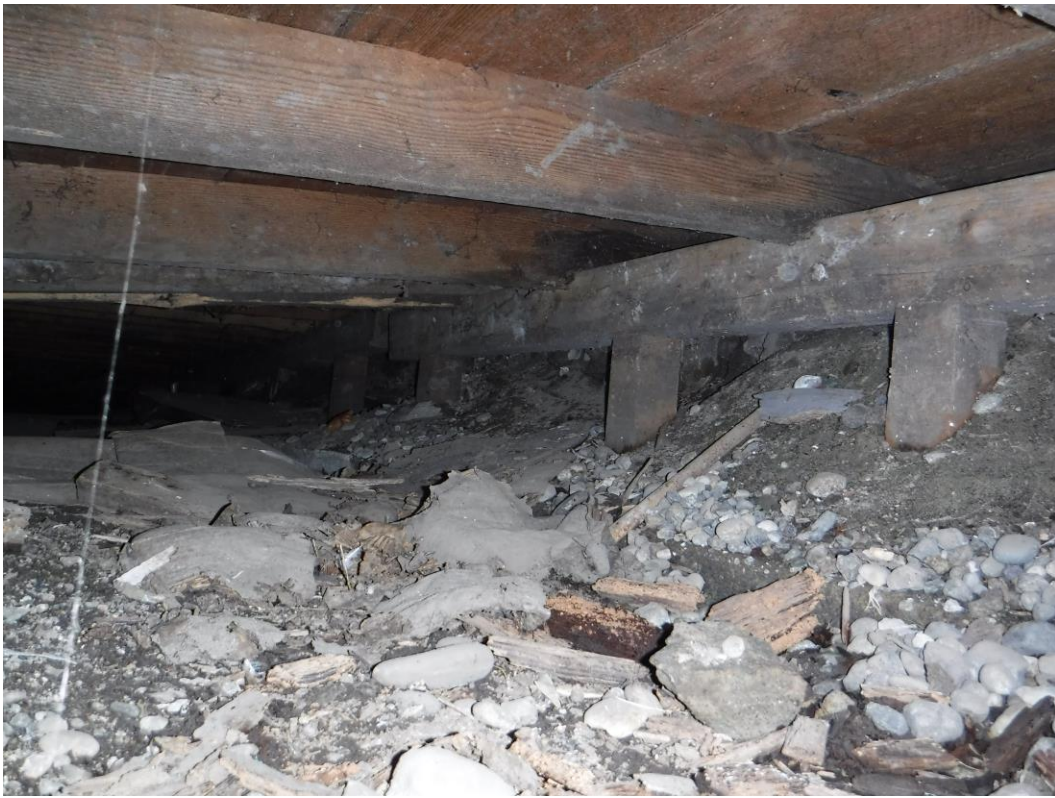
Photograph 15: Underside of first floor.
