PORT OF SILVERDALE
2019 COMPREHENSIVE PLAN

APPENDIX F: OLD TOWN PUB STRUCTURAL ANALYSIS

September 10, 2018
File No. 262018.077

Subject: Port of Silverdale Old Town Pub
Structural Evaluation

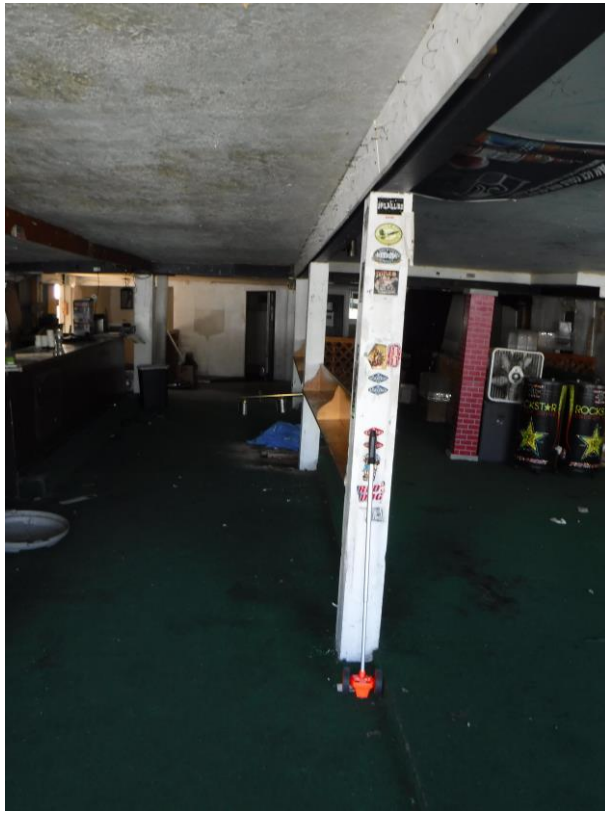
Photograph 9: Interior line of columns at first floor.

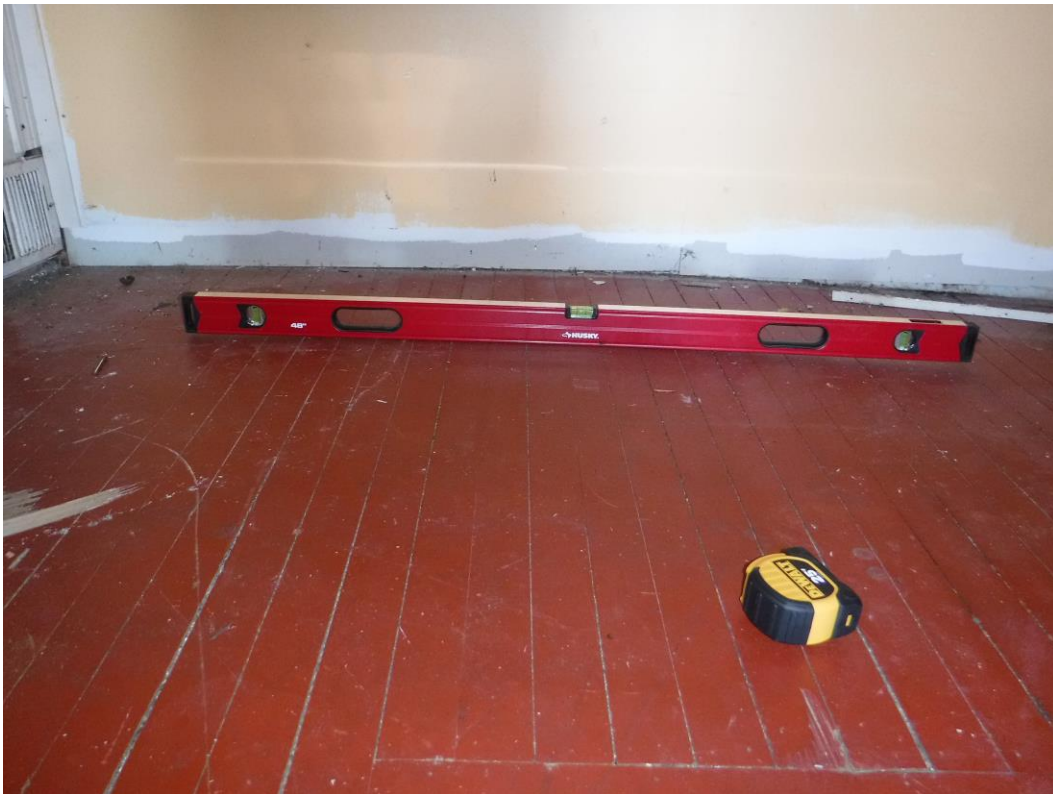
Photograph 12: Second floor at building center with high point (slope east and west).

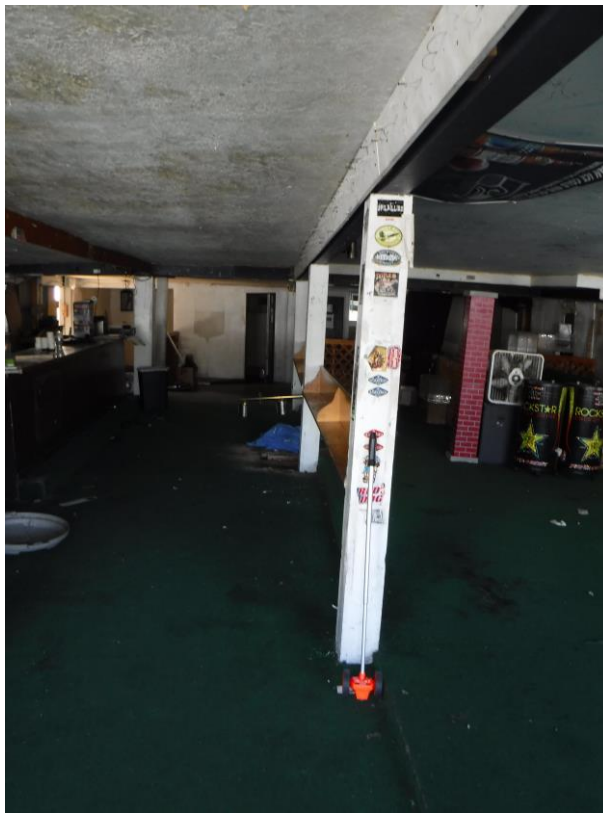
Photograph 9: Interior line of columns at first floor.
