PORT OF SILVERDALE
2019 COMPREHENSIVE PLAN

APPENDIX F: OLD TOWN PUB STRUCTURAL ANALYSIS

September 10, 2018
File No. 262018.077

Subject: Port of Silverdale Old Town Pub
Structural Evaluation

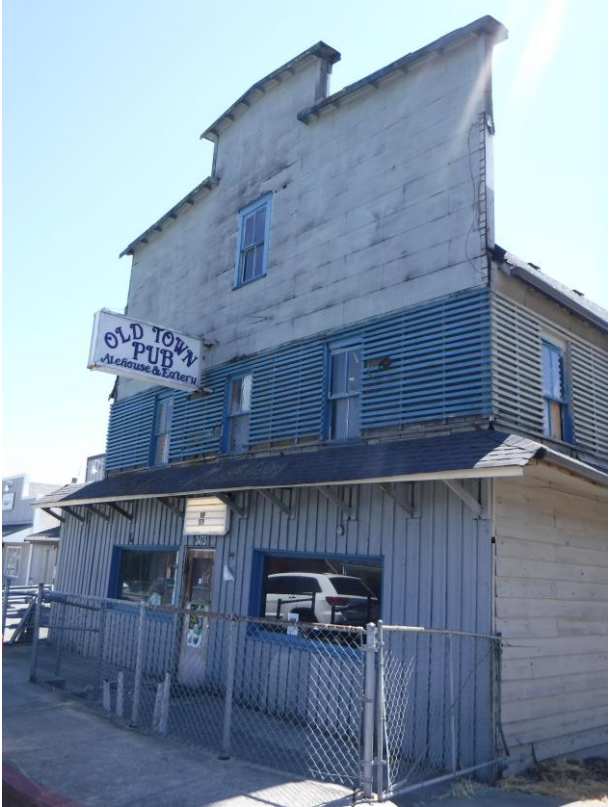
Photograph 1: Northern exterior of building.

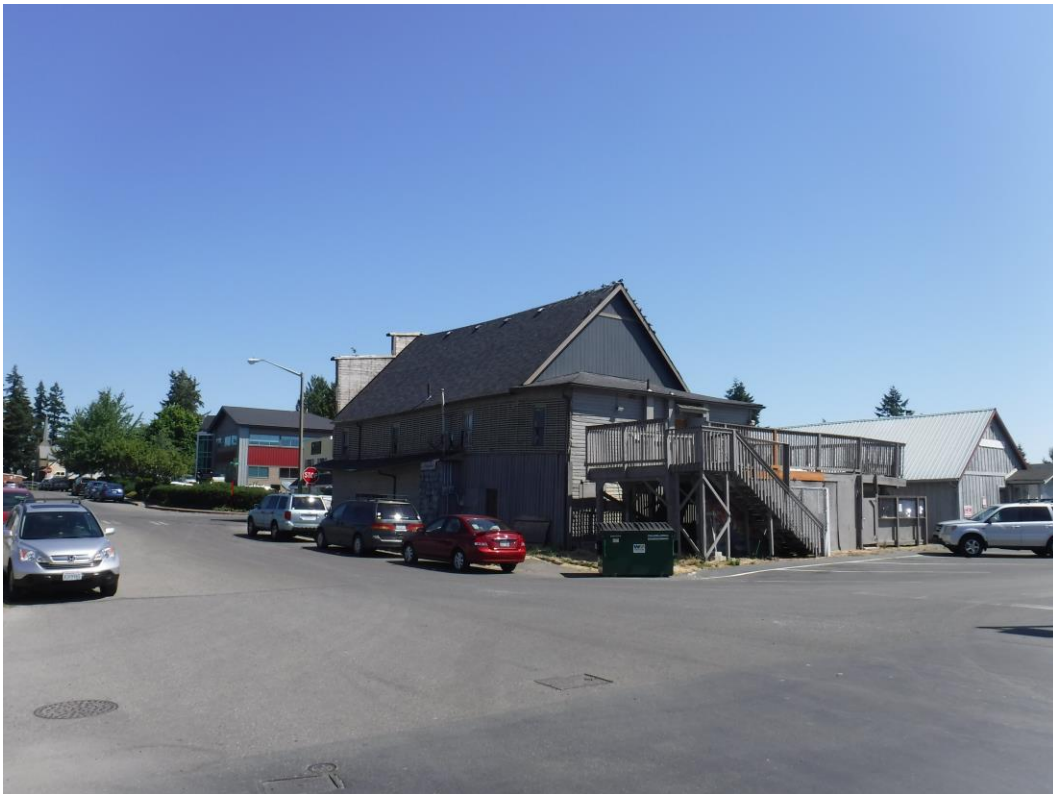
Photograph 3: Southwestern exterior corner of building.

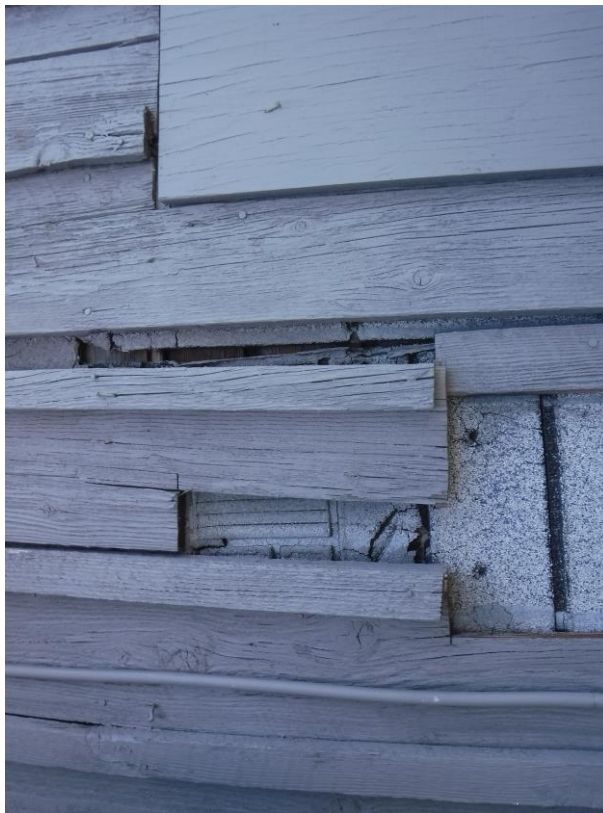
Photograph 7: Typical exterior shiplap.

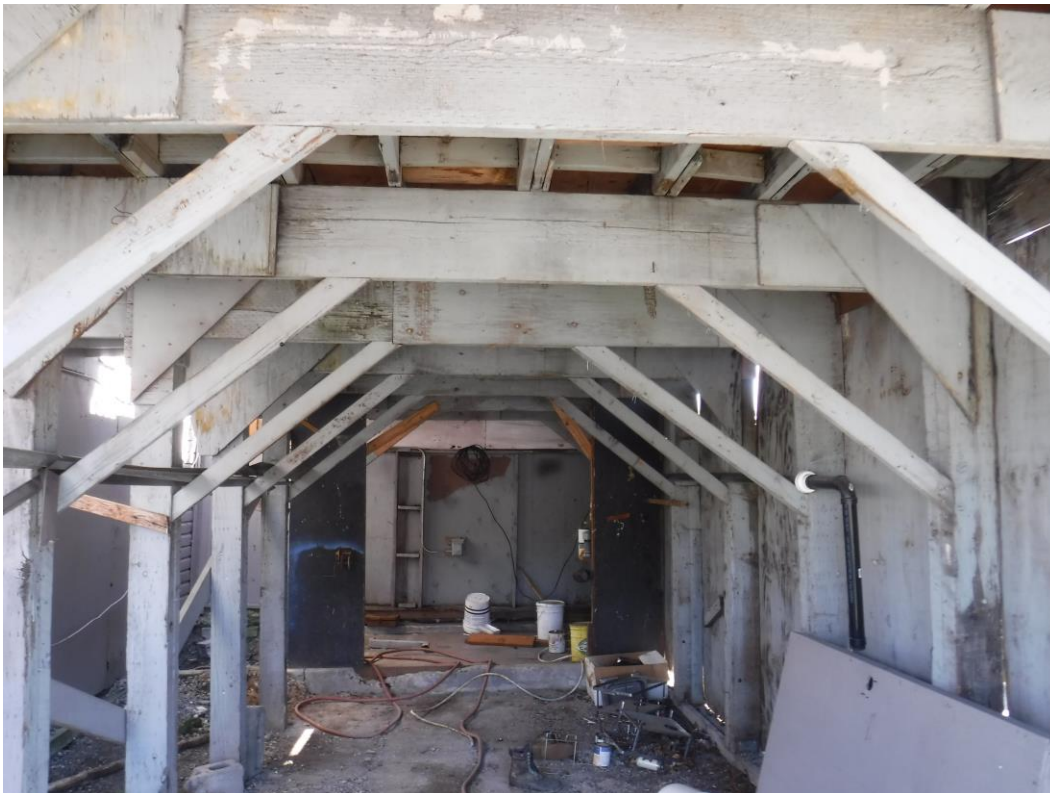
Photograph 8: Underside of deck at southern side of building.

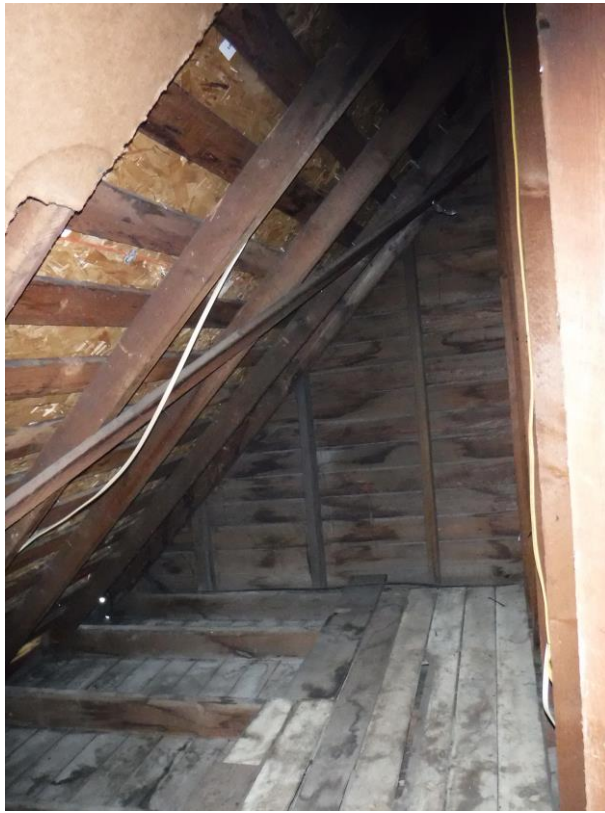
Photograph 14: Western interior with exposed truss top and bottom chords.

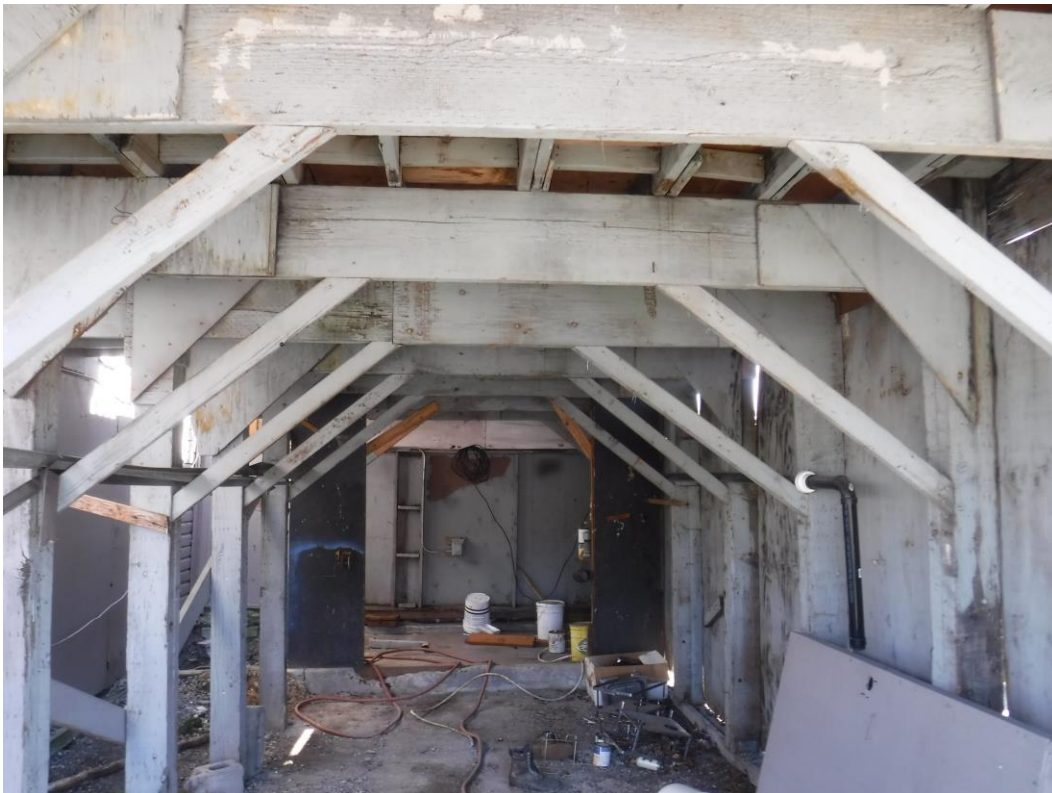
Photograph 8: Underside of deck at southern side of building.

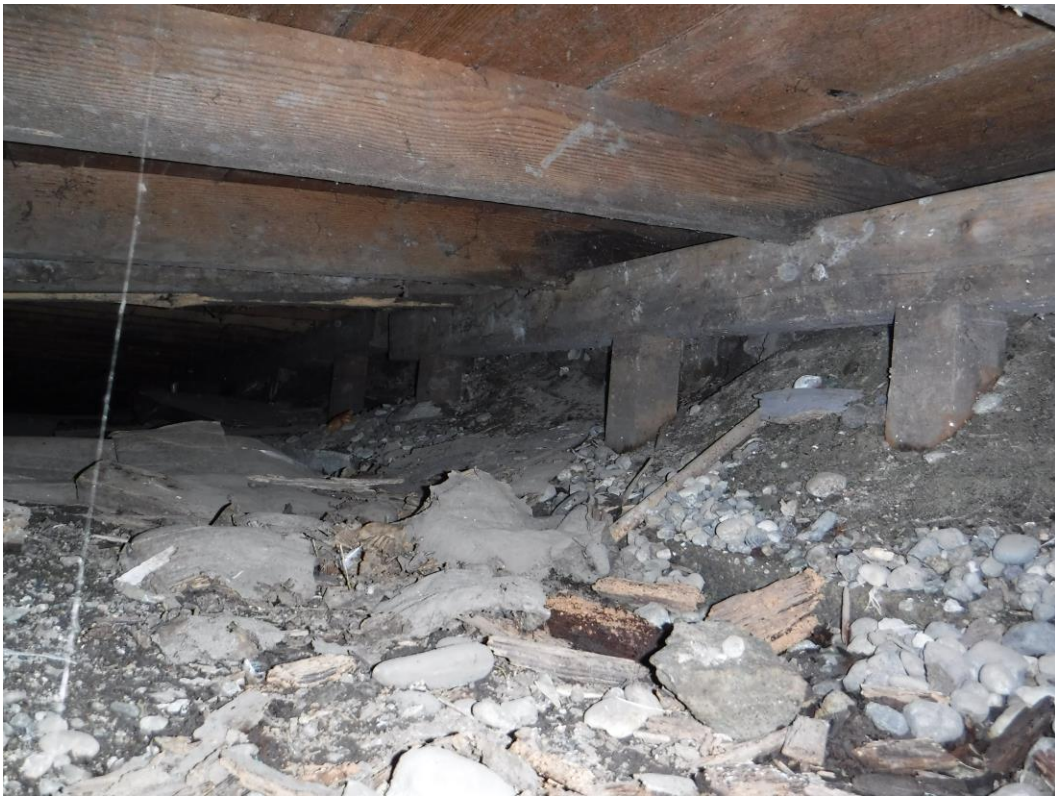
Photograph 16: Typical foundation system and underside of first floor.

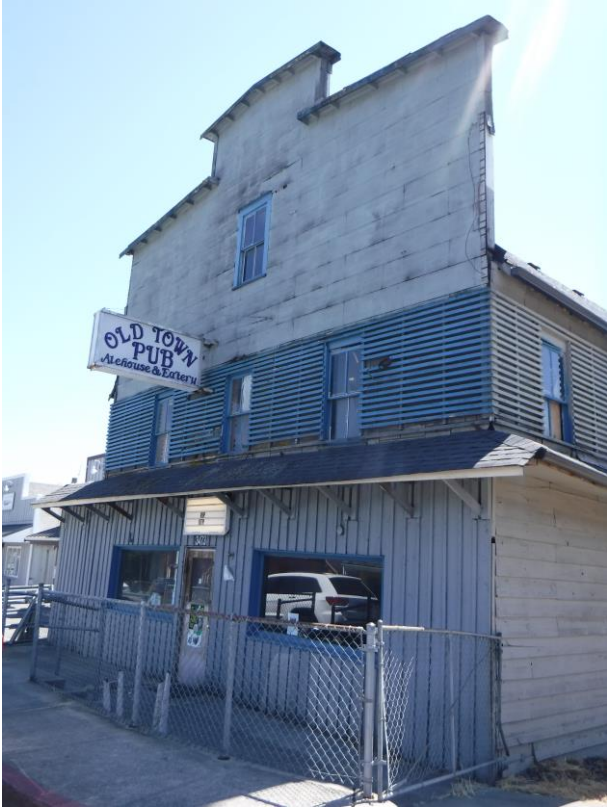
Photograph 1: Northern exterior of building.

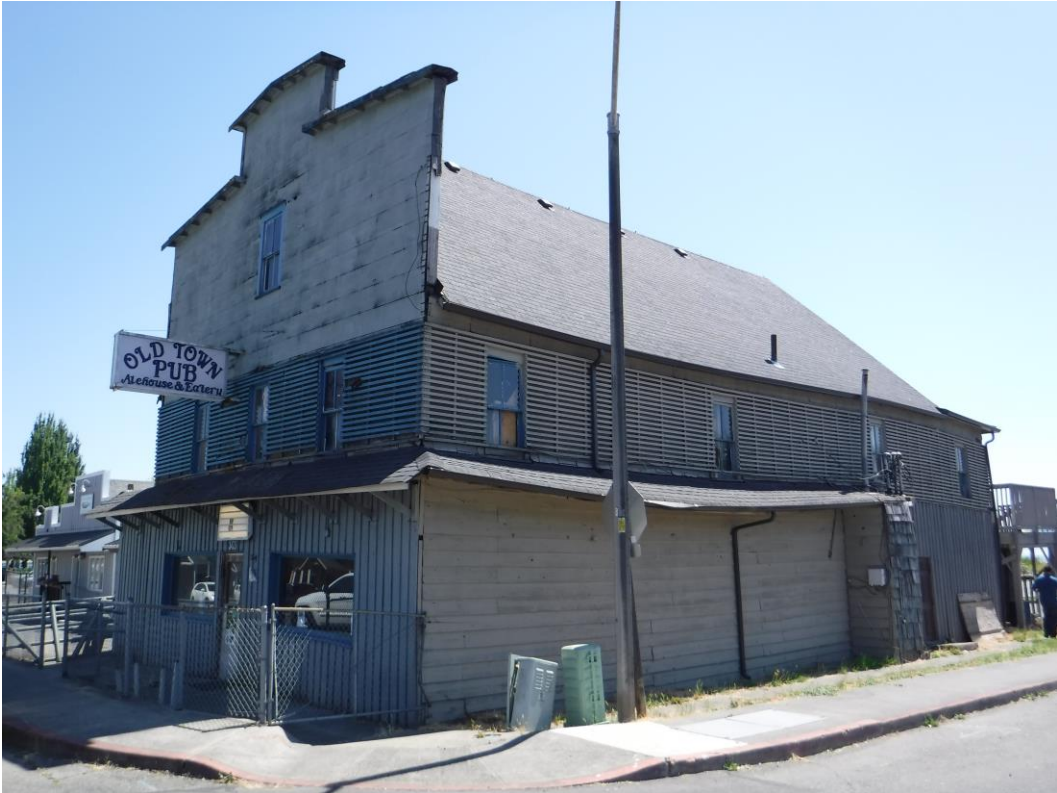
Photograph 2: Northwestern exterior corner of building.

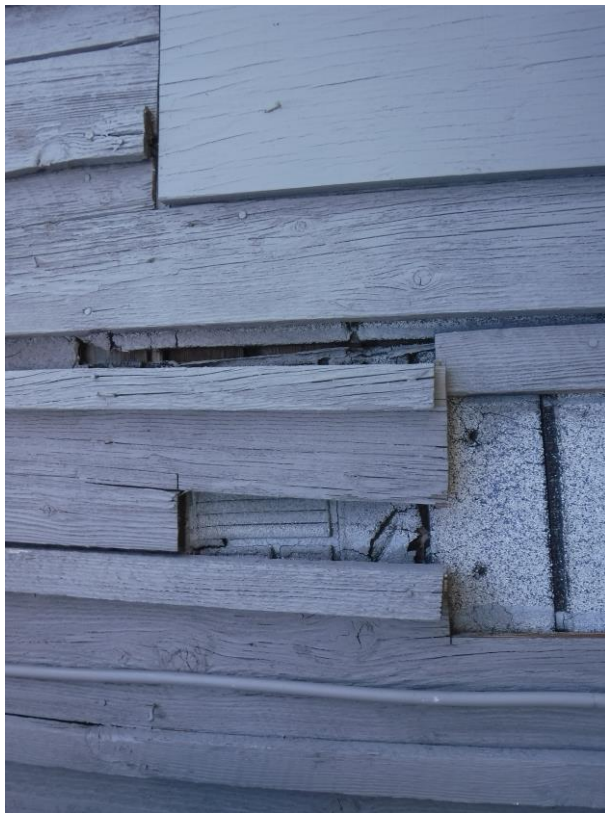
Photograph 7: Typical exterior shiplap.

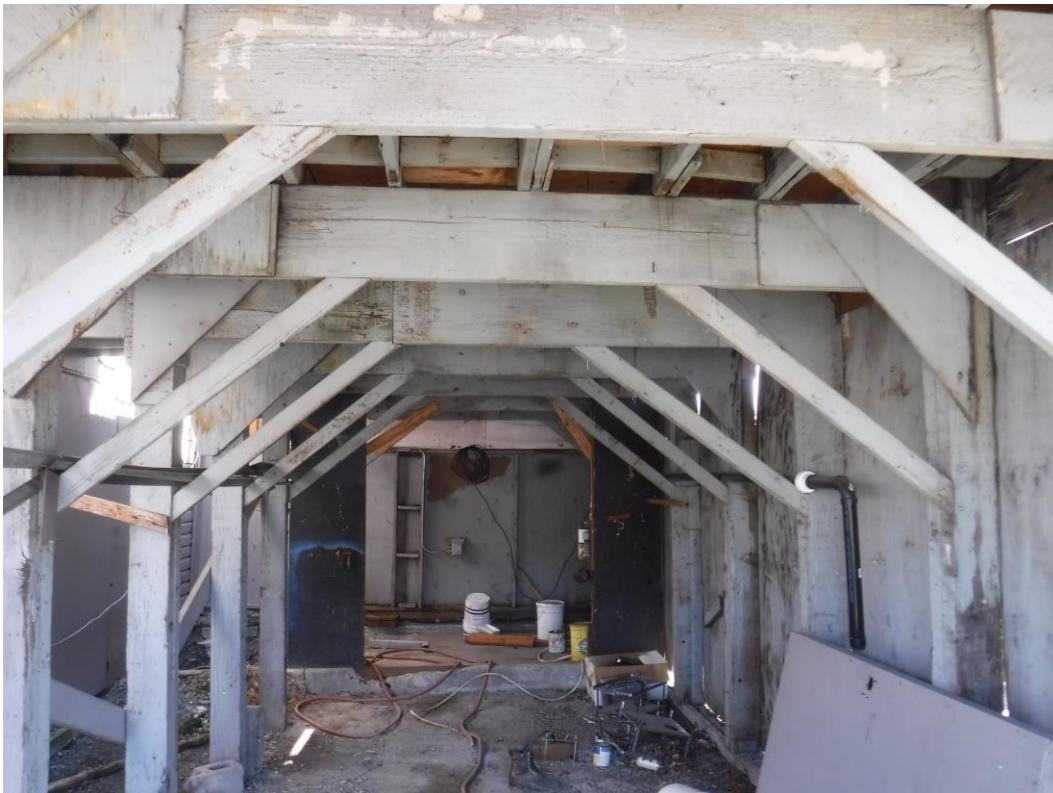
Photograph 8: Underside of deck at southern side of building.

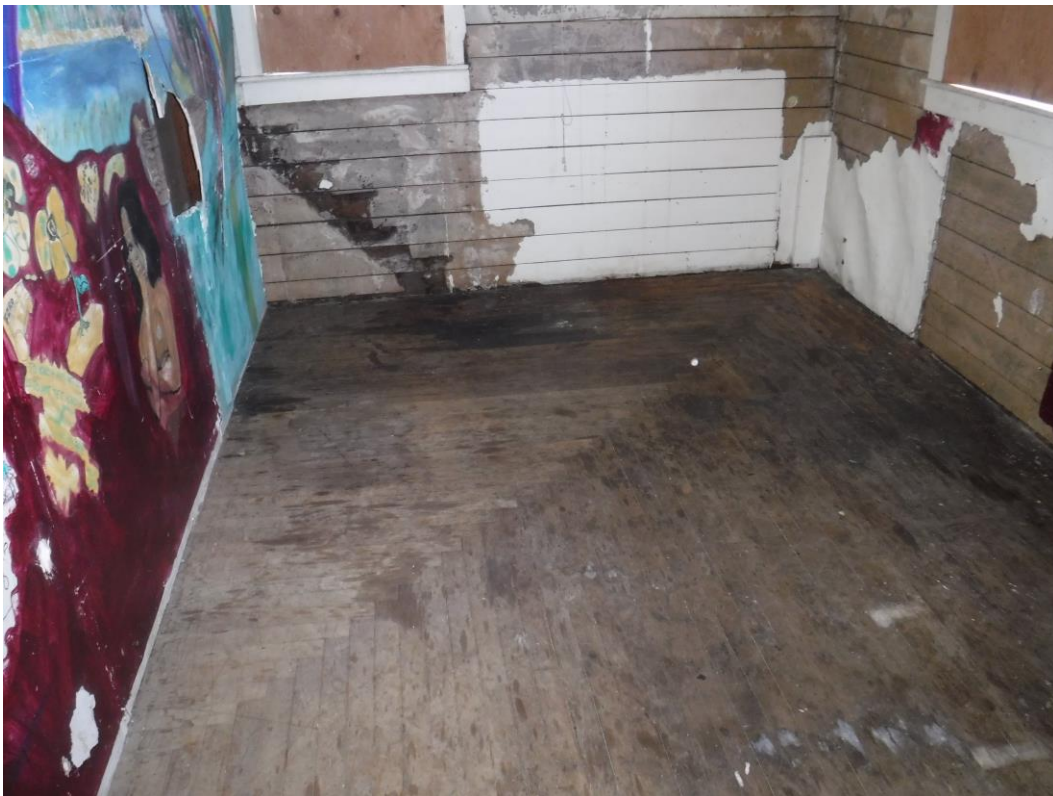
Photograph 11: Typical floor and walls (second floor shown).

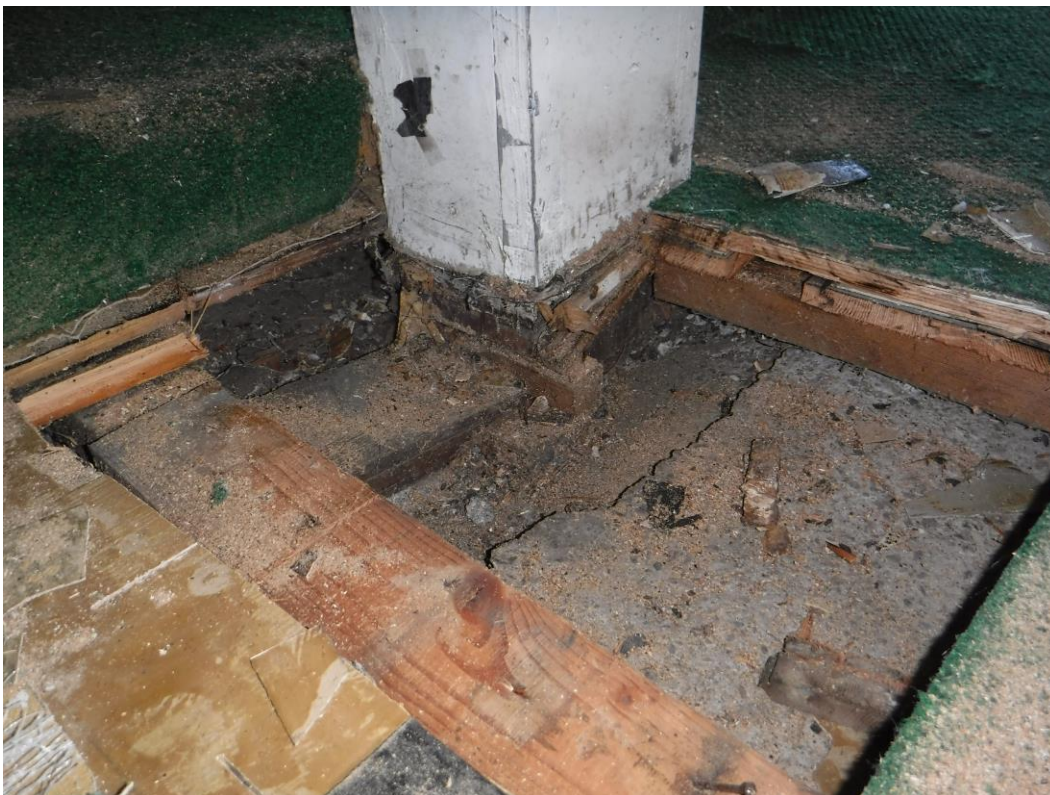
Photograph 10: Hole cut at column base at first floor.
